OPERATING EXPERIENCE WEEKLY SUMMARY

Office of Nuclear and Facility Safety

March 19 - March 25, 1999

Summary 99-12

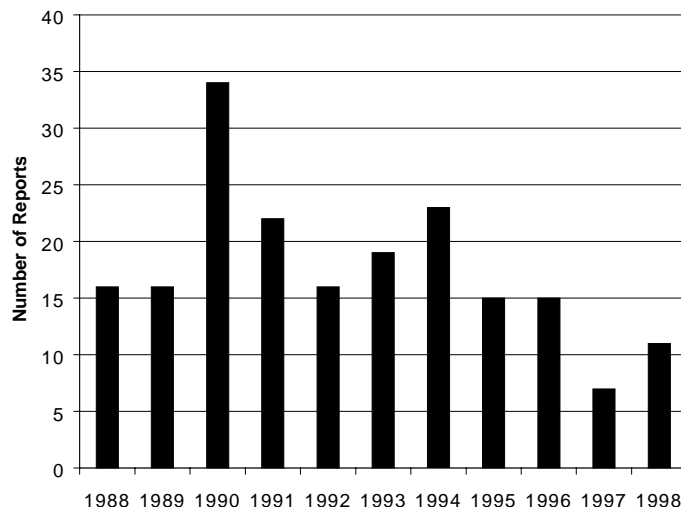
The Computerized Accident Information Reporting System (CAIRS) database lists 194 accidents involving compressed gas cylinders over the last 11 years. Although there has been an overall downward trend in the number of accidents attributable to compressed gas cylinders since 1990, the number of accidents remains significant, pointing to a continuing need for an awareness of and adherence to compressed gas cylinder safety requirements.

Figure 5-1. Compressed Gas Cylinder Accidents¹

These events emphasize the need to exercise extreme care when handling compressed gas cylinders. Compressed gas cylinders can be large, heavy, and difficult to handle and can cause serious personnel injury. They should be properly secured at all times to prevent tipping, falling, or rolling. They can be secured with straps or chains connected to a wall bracket or other fixed surface, or by use of a cylinder stand. Cylinders should be stored in an area where they will not be knocked over or damaged by falling objects. When a cylinder is not being used, the valve should be closed and the valve cap secured hand-tight. When a valve cap is being installed, it should not be spun; it should be rotated slowly until seated. A torque device should not be used to tighten a valve cap. To avoid damaging or accidentally opening a cylinder valve, there should be no attempt to remove a stuck or jammed valve cap using a leverage device through the cap. With the cylinder firmly secured, a noninvasive device such as a strap wrench should be used to loosen the cap, or a tag or label identifying the problem should be attached to the cylinder and the cylinder returned to the supplier.

Managers at DOE facilities should ensure that compressed gas cylinder safety is an integral part of the facility safety program. NFS has issued Safety Notice DOE/EH-0527, *Compressed Gas Cylinder Safety*, which contains summaries, corrective actions, lessons learned, recommendations related to compressed gas cylinder events, and additional references. Safety Notices are available at http://tis.eh.doe.gov/web/oeaf/lessons_learned/ons/ons.html.
